NASA Technical Memorandum 105807

# Nondestructive Evaluation of Ceramic and Metal Matrix Composites for NASA's HITEMP and Enabling Propulsion Materials Programs

Edward R. Generazio  
*Lewis Research Center*  
*Cleveland, Ohio*

August 1992

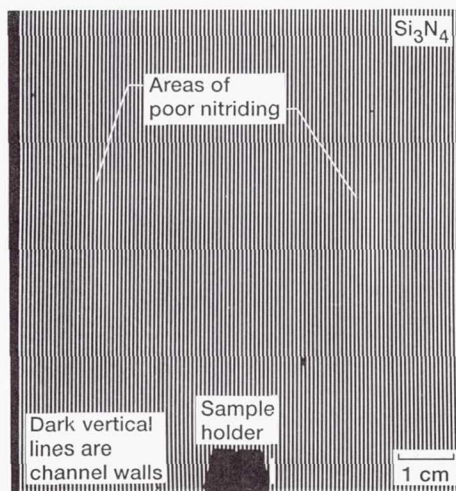
We begin our study with the development of a  $\text{Si}_3\text{N}_4$ /SCS-6 (ref. 15) panel that contains coolant channels (fig. 1). The actively cooled panel is made up of a monolithic, 10.0 by 10.0 cm,  $\text{Si}_3\text{N}_4$  slab that is laminated to a cross-ply composite panel  $\text{Si}_3\text{N}_4$ /SCS-6 [0-90]. The laminated panel is 0.335 cm thick. The monolithic panel has 0.05 cm wide and 0.05 cm high coolant channels. The channel walls are 0.05 cm thick. During the development of this panel the interlaminar bonding procedure is evaluated by bonding two similar but monolithic plates. The bond between planar layers may be evaluated with radiographic and through transmission, focused 10 MHz, ultrasonic c-scan analysis; the results are shown in figures 2 and 3, respectively. A low x-ray intensity, i.e., high x-ray attenuation, corresponds to dark region in the x-ray film positive. The dark vertical bands in the radiograph correspond to the walls of the coolant channels. The channels are uniform in shape and there are no chips, cracks or occlusions present. There are two lighter vertical bands at areas where poor reaction of the bonding material produced low densities. (A subsequent modification of the manufacturing process eliminated these poorly reacted areas.)

Figure 2.—Radiograph of monolithic  $\text{Si}_3\text{N}_4$ , actively cooled panel.

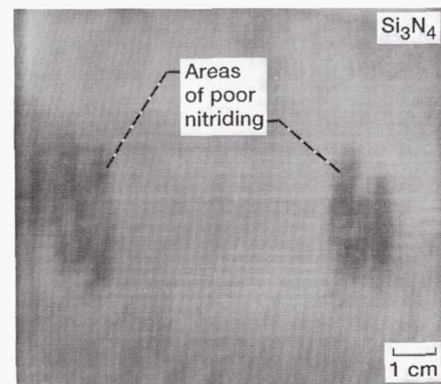
The ultrasonic c-scan shows these poorly reacted regions more clearly and to be somewhat larger than that observed in the radiograph. The condition of the channels can not be determined from the ultrasonic information.

Figure 3.—Ultrasonic, 10 MHz, through transmission c-scan of monolithic  $\text{Si}_3\text{N}_4$ , actively cooled panel.

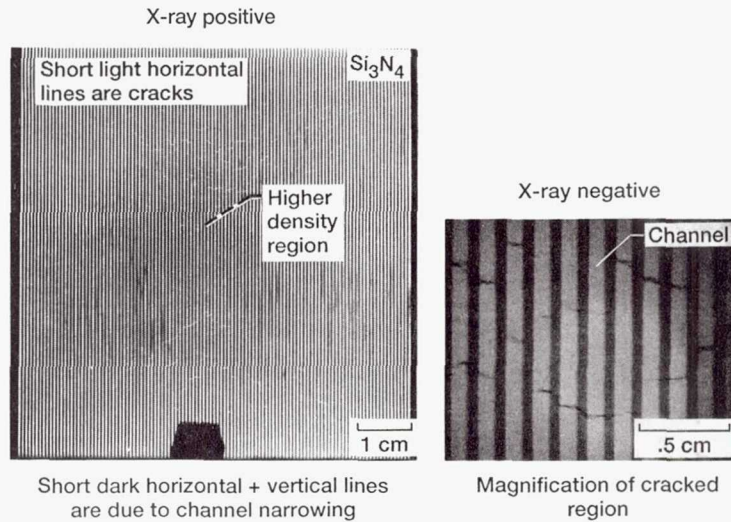
Figures 4 and 5 show the radiographic and focused 10 MHz, ultrasonic c-scan results for a  $\text{Si}_3\text{N}_4/\text{SCS-6 } [0^\circ]$  panel. Severe microcracking is observed in the radiograph as short light horizontal lines. The microcracks are most visible at the walls of the coolant channels. Note that in the enlarged region of the radiograph the crack lengths are not limited to the channel wall thickness but actually are several channels wide. The short dark vertical lines scattered throughout the image each have a short horizontal dark line at their central regions. These short dark vertical regions are regions where the channel has decreased in width. The dark horizontal line at the center of each of these regions, when examined at high magnifications, has been found to be an optical illusion that occurs where the channel walls have the closest approach to each other. At the region of closest approach some channels are partially blocked by this narrowing of the channel. Several channels had adjacent walls that were of sufficient thickness that the walls were touching and apparently completely blocking the channel. The ultrasonic image reveals a considerable amount of disordered mottling in the structure. The radiograph does exhibit density variations. There is no correlation between the mottling structure in the ultrasonic c-scan image and the crack structure observed in the radiograph. This mottling is due to porosity and bond variations between the laminated layers (refs. 16 to 22).

Figure 4.—Radiographs of  $\text{Si}_3\text{N}_4/\text{SCS-6}$  [0 degree] actively cooled panel.

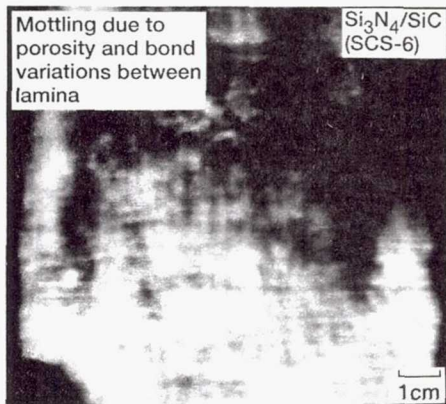
Figure 5.—Ultrasonic, 10 MHz through transmission c-scan of  $\text{Si}_3\text{N}_4/\text{SiC}$  SCS-6 [0 degree] actively coolant panel.

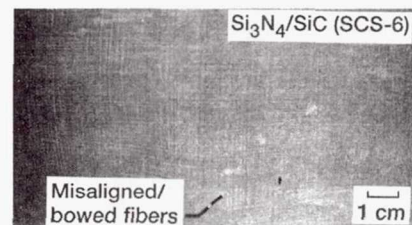
In the previous example the fiber orientation is not easily determined. Figures 6 and 7 show the radiographic and focused 10 MHz, ultrasonic, c-scan images of a  $\text{Si}_3\text{N}_4/\text{SCS-6 } [0/90^\circ]$  composite panel that does not have coolant channels. The radiograph reveals a bowed fiber system. These bowed patterns are not actual individual bowed fibers but are x-ray "shadows" of a collection of fibers that are bowed. The shadows forming the bowed pattern are due to fiber volume density variations through the thickness and perpendicular to the x-ray film plane. This is manifestation of the Moiré effect (refs. 18 and 23) found in composite systems. The density of the system is uniform as indicated by the uniform gray level or shading in the radiograph. The dark areas in the ultrasonic image also yielded reflected ultrasonic signals that corresponded to reflections from the laminated boundary, these dark areas are regions having poor or no bond between laminated layers.

Figure 6.—Radiograph of  $\text{Si}_3\text{N}_4/\text{SiC}$  SCS-6 [0-90 degree] panel.

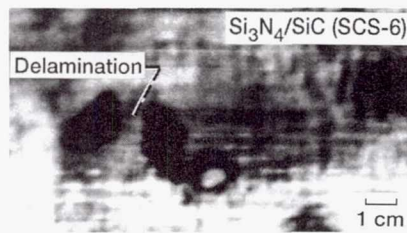
Figure 7.—Ultrasonic, 10 MHz, through transmission c-scan of  $\text{Si}_3\text{N}_4/\text{SiC}$  SCS-6 [0-90 degree] panel.

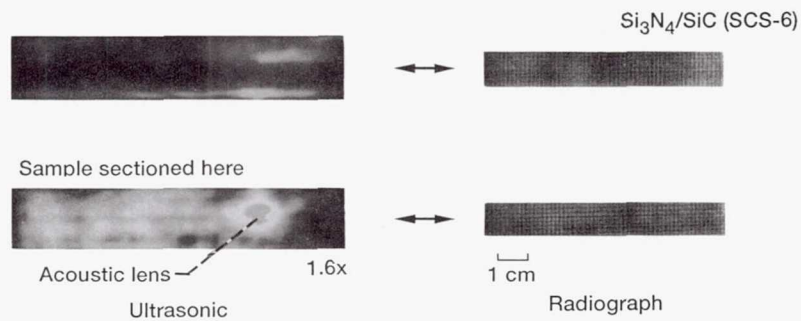
Fibers need only be well ordered and spaced uniformly in the plane of a  $\text{Si}_3\text{N}_4/\text{SCS-6 } [0/90]$  plate in order to yield relatively uniform radiographic and ultrasonic images (fig. 8). However, if there are any systematic variations, such as, ordered through the thickness buckling (due to processing) of the fibers (fig. 9), then the ultrasonic image will reveal this systematic fiber spacing variations. The fiber buckling can be readily observed in the photomicrograph (fig. 9) by comparing the spacing between the bottom two rows of fibers that are perpendicular to the cross section. Note that this spacing varies dramatically from center to the right edge of the sample. In this case, the fibers are forming a crude diffractive/refractive acoustic lens (fig. 9) that is observed as a bright spot in the ultrasonic image. No indication of this fiber buckling is seen in the radiograph.

Figure 8.—Ultrasonic, 10 MHz, through transmission c-scan and radiographs of similarly produced  $\text{Si}_3\text{N}_4/\text{SiC}$  SCS-6 [0-90 degree], test bars.

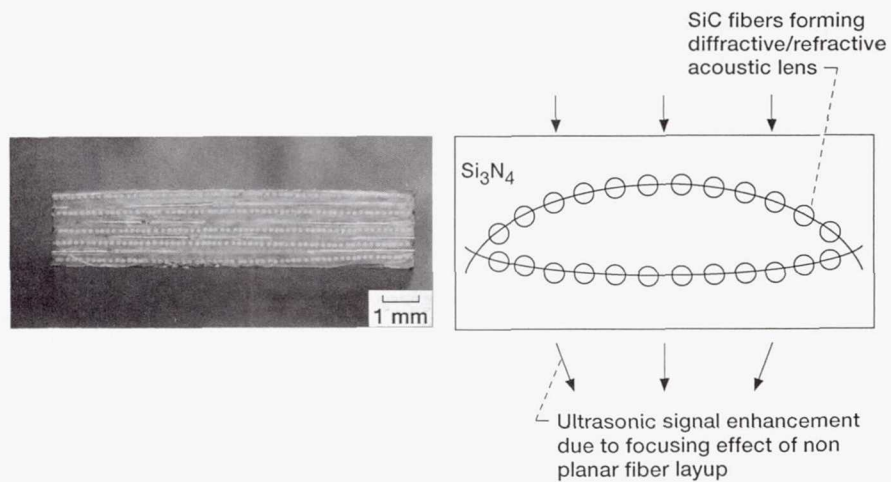
Figure 9.—Cross-section of  $\text{Si}_3\text{N}_4/\text{SiC}$  SCS-6 [0-90 degree] test bar at region showing large ultrasonic transmission.

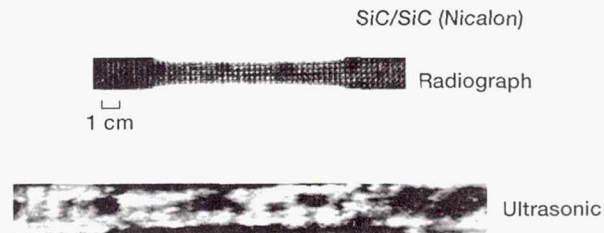
A SiC/SiC (Nicalon fiber) laminated, two-dimensional, woven composite yield very complicated radiographic and focused 10 MHz, ultrasonic c-scan (fig. 10) images. The radiograph reveals a cross hatch pattern that varies in density. This variation may be due to density variations in the matrix material or registration variations between the woven layers. The dark circular regions that are uniformly spaced are due to local density variations that have been produced during processing. These circular density variations are also visible in the ultrasonic image. The distorted or blurry appearance of

the ultrasonic images is due to refractive and diffractive scattering (ref. 17) occurring at the rough surfaces and woven fibers. There is little additional information obtained from the 10 MHz, ultrasonic c-scan.

Figure 10.—Ultrasonic, 10 MHz through transmission c-scan and radiograph of SiC/SiC (Nicalon) woven laminated composite.

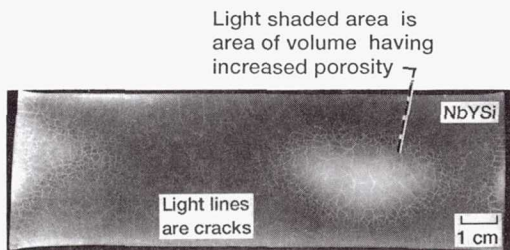
During the development of potential metal matrices the processing procedures are optimized by a combination of methods. One technique developed for consolidating metallic glass powders requires the use of a molybdenum or niobium encapsulating can for hot isostatic pressing (HIP). Radiographic (fig. 11) and ultrasonic (fig. 12) imaging can be performed while the consolidated material, NbYSi is still encapsulated. The radiograph reveals an extensive amount of cracking throughout the consolidated material. Regions of increased porosity can be readily identified as light cloud-like areas in the radiograph and dark areas in the ultrasonic image. The crack density increases with an increase in porosity.

Figure 11.—Radiograph of encapsulated NbYSi matrix material.

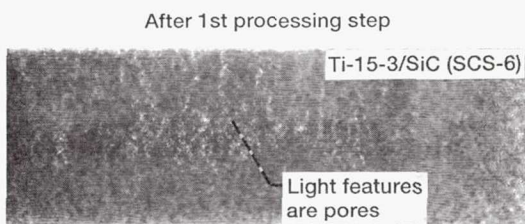
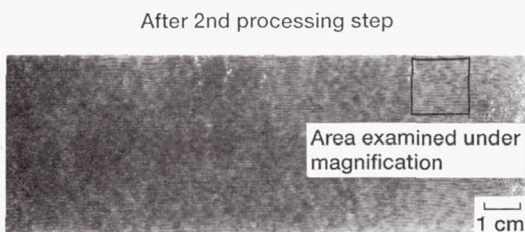
The degree of consolidation was monitored in Ti-15-3/SiC (SCS-6) fiber composites with radiographic (fig. 13) and ultrasonic imaging (fig. 14). This panel was HIPped in two steps. The second processing step has removed much of the porosity (fig. 13). A close examination of the radiograph reveals fine fiber fractures (fig. 15). The intensity of the x-rays at the fracture sites is low. This low intensity or high x-ray attenuation at the fracture sites is an indication that the matrix material has infiltrated into these fracture sites as shown in figure 15. An increase in the x-ray intensity at the fracture sites would indicate that these fracture sites contained voids. The fractures occurred during the ductile part of the HIP stage and are not due to the mismatch between the coefficients of thermal expansion of the fiber and matrix materials. The initial infiltration of the matrix into the fiber fracture sites was radiographically observed after the first HIP stage.

Figure 13.—Radiographs of Ti-15-3/SiC (SCS-6) composites after first and second processing steps.

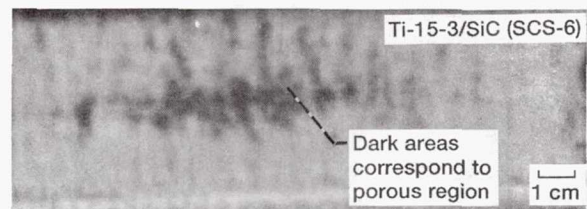
Figure 14.—Ultrasonic, 10 MHz, through transmission c-scan of Ti-15-3/SiC (SCS-6) composite after the first processing step.

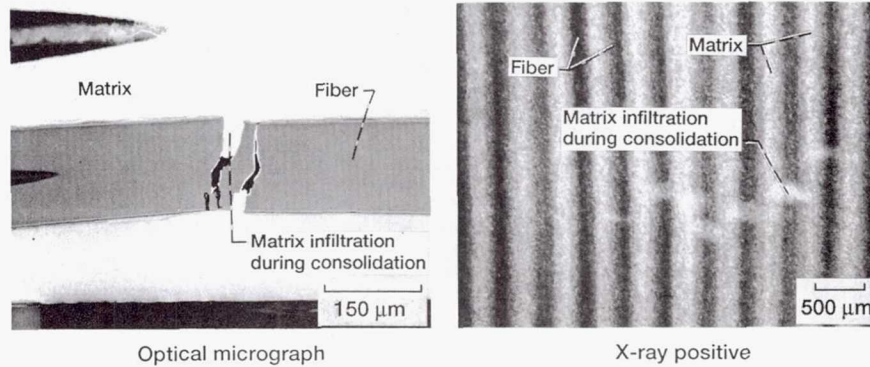
Figure 15.—Metallograph and enlarged x-ray positive of region highlighted in figure 13.

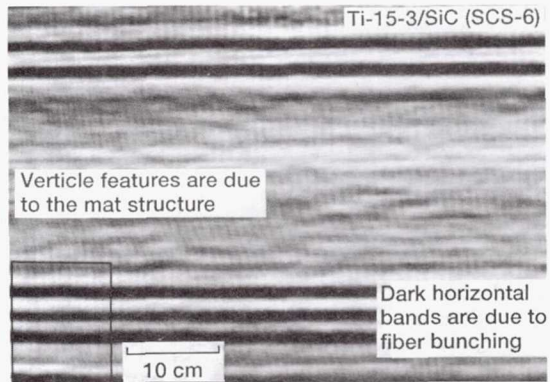
Composites with three phases yield complex radiographic and ultrasonic data. A Ti-15-3 plate containing unidirectional SiC (SCS-6) fibers and a molybdenum wire mat represents a simple three phase composite system. Groups of molybdenum wires can be identified in the focused 10 MHz, ultrasonic c-scan image (fig. 16) as faint uniformly spaced vertical lines. Here each group of mat wires act as an ultrasonic line scatter. Dark horizontal bands in the upper and lower parts of the ultrasonic image are due to the slight bunching of the horizontal SiC fibers, i.e., areas having high fiber volume density. The central region of the ultrasonic image also exhibits some horizontally oriented mottling. This mottling is due to similar fiber volume density variations except that these fiber volume density variations are not as ordered as those near the upper and lower edges of the plate. The radiograph shows both the orientation and structure of the horizontal SiC fibers and the vertical molybdenum wires that make up the mat (fig. 17). Broken, twisted, and bent molybdenum wires are easily identifiable and occur throughout the system. Fiber rich banded zones can also be identified, but not easily, in the radiograph.

Figure 16.—Ultrasonic, 10 MHz, through transmission c-scan of Ti-15-3/SiC (SCS-6) composite.

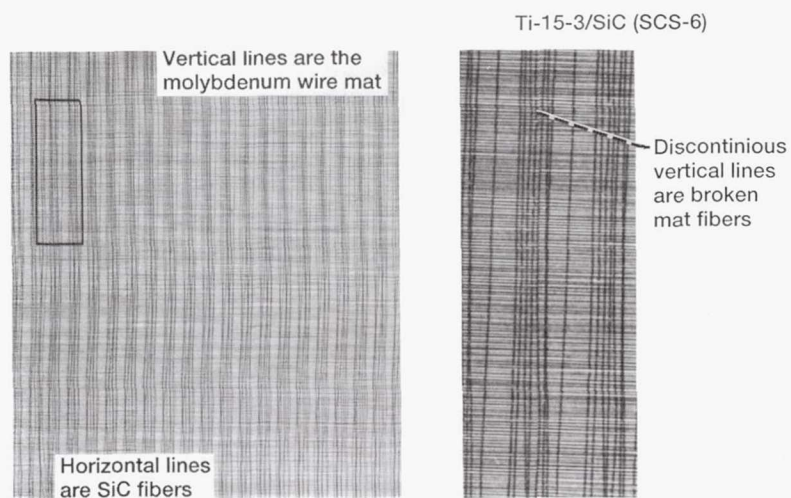
Figure 17.—Radiograph of highlighted region in figure 16.

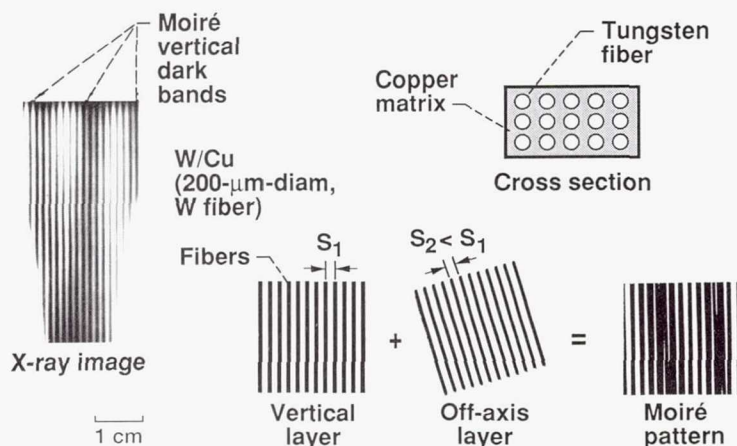
Ordered or systematic changes in the fiber volume density or orientation can produce artifacts or Moiré (refs. 17 and 23) patterns in the radiographs. For example, if in one layer, the fiber spacing, S1, is slightly different from the fiber spacing, S2, in another layer, then a Moiré pattern will be observed in the radiograph. The radiograph of a copper matrix system containing tungsten wires (fig. 18) reveals broad vertical dark Moiré bands. (This is not an advanced high temperature composite material for the HITEMP or EPM programs, but it does dramatically show an artifact that occurs in all continuous fiber composites to some degree.) In addition, if the fiber layers are also off-axis from each other then the Moiré bands will also be off-axis.

Figure 18.—Radiograph and illustrations showing Moiré effect in W/Cu composite.

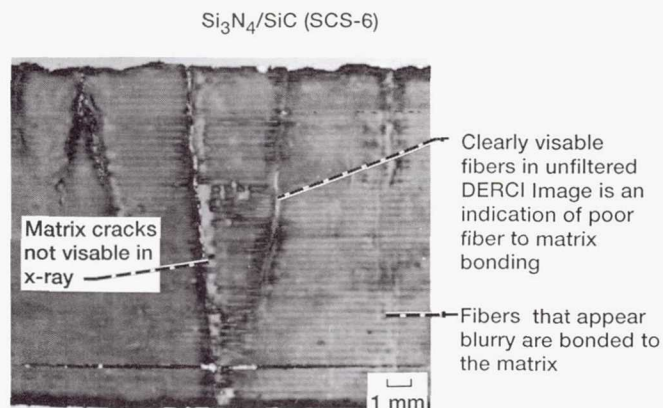
A  $\text{Si}_3\text{N}_4/\text{SiC}$  [0] (SCS-6 fiber) composite was tested in tension until matrix cracking was visually observed. The specimen was then unloaded and a NDE was performed. A region of the specimen was identified that did not visually exhibit matrix cracking. A radiograph of this area reveals a uniform structure (fig. 19). A microscopic evaluation of the radiograph does not reveal the presence of any microcracks. However, a 50 MHz, ultrasonic DERICI image (fig. 20) reveals a detailed subsurface structure. The individual subsurface fibers of the first ply can be identified as horizontal features across the image. The vertical and near vertical features are cracks in the matrix material. Note that along and near the matrix cracks there are areas in the image where the fibers appear to be clear or less blurry. The fibers in these areas have decoupled from the matrix material and in doing so have formed nearly perfect cylindrical ultrasonic scattering boundary. This rather clean boundary prohibits any secondary or blur inducing scattering of the wave that would have occurred if the ultrasound travelled into the SiC fiber (fig. 21). A florescent dye penetrant makes these matrix cracks visible under an ultraviolet light (fig. 22).

Figure 20.—Ultrasonic DERCi unfiltered image at 50 MHz of section of  $\text{Si}_3\text{N}_4/\text{SiC}$  SCS-6 [0] RBSN tensile test bar.

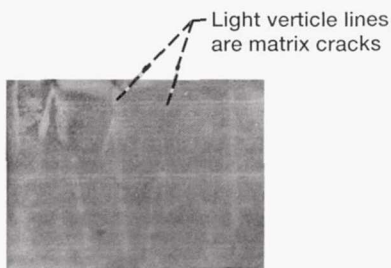
Figure 22.—Fluorescent penetrant image of section of  $\text{Si}_3\text{N}_4/\text{SiC}$  SCS-6 [0] RBSN tensile test bar.

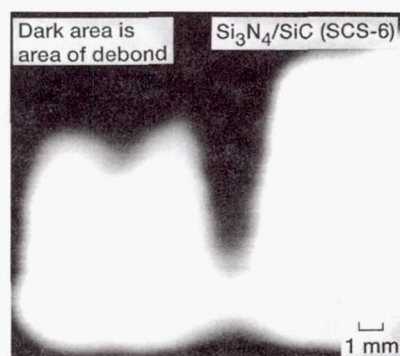
An extensive amount of ultrasonic scattering is observed in a 10 MHz, ultrasonic c-scan (fig. 25). The dark areas in the ultrasonic image correspond to the areas where cracks are observed in the DERICI image.

Figure 25.—Ultrasonic, 10 MHz, through transmission c-scan of section of  $\text{Si}_3\text{N}_4/\text{SiC}$  SCS-6 [0] RBSN tensile test bar.

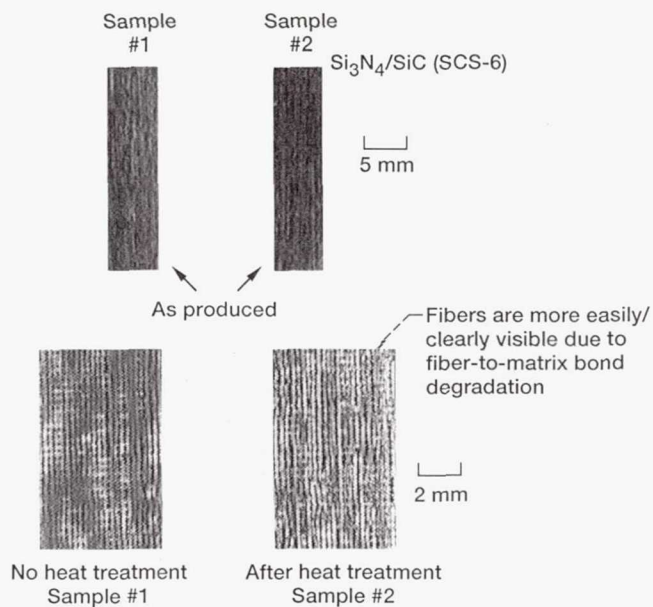
Two identically produced specimens of  $\text{Si}_3\text{N}_4/\text{SiC}$  (SCS-6) [0] were ultrasonically evaluated using the DERICI technique. The DERICI images are spatially filtered with a two-dimensional high pass filter before further evaluation. This filter extracts the important spatial high frequency components (i.e., reflections from the fiber-to-matrix interface) from the reflections from porosity which are generally observed as mottling in ceramics (refs. 16 to 22 and figs. 5 and 7). The DERICI results reveal similar features in both samples before heat treatment (fig. 26). The vertical features in these images are due to reflections at the subsurface fiber-to-matrix interfaces. One sample was heat treated at 600 °C for 100 hr in flowing oxygen to degrade the fiber-to-matrix interface (via oxidation) (ref. 24). This heat treatment decreased the interfacial shear strength from  $18 \pm 4$  MPa to  $0.8 \pm 0.4$  MPa (ref. 24). After heat treatment there is a marked change in the DERICI image. After heat treatment the reflections from the interface are more intense so that the fibers become more visible. This change in the DERICI results before and after heat treatment can be quantified. The histogram maximum of the gray scale of each of the images may be used to quantify the DERICI results (fig. 27). A low value for the histogram maximum indicates that there is considerable amount of scattering at the fiber-to-matrix interfaces per unit area. A high maximum value indicates that the fibers are difficult to observe and that the image is rather bland or smooth. Ideally, if the fibers were perfectly bonded, and therefore essentially unobservable (except for the small variation in the acoustic impedance between the fiber and matrix) then the DERICI images would contain predominantly one shade, 128, in the gray scale. The gray scale maximums for the untreated and heat treated specimens are 1.9 and 3.3 (arbitrary units), respectively. This corresponds to about a 75 percent change in histogram amplitudes. These values can be correlated with the respective interfacial

Figure 26.—DERCI images of  $\text{Si}_3\text{N}_4/\text{SiC}$  SCS-6 [0] RBSN at 50 MHz before and after heat treatment.

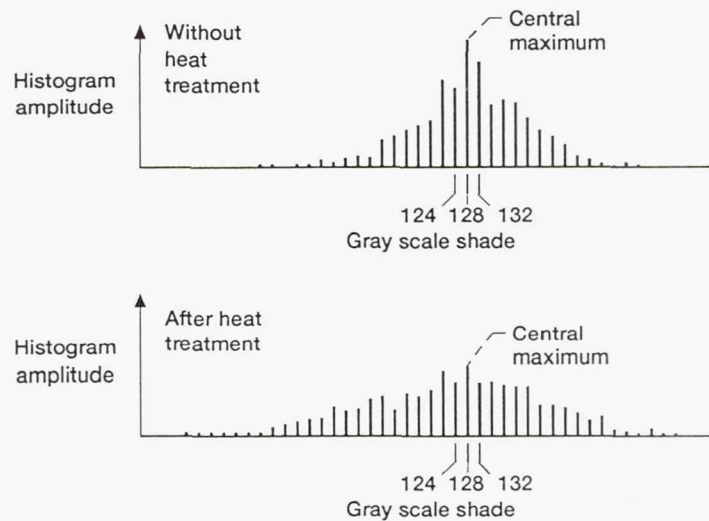
shear strengths. If the interfacial shear strength is strongly dependent on the contact area between the fiber and matrix, then the DERC results, which are also sensitive to changes in this contact area, are images of variations in interfacial shear strength. Since the fiber and matrix acoustic impedances are not identical, then the interrelationship between the DERC results and the interfacial shear strength, which to first approximation is assumed to be a linear relationship, will contain a calibration or scale factor. The radiographs before and after the heat treatment (fig. 28) show essentially similar results.

Figure 27.—Histograms of DERCI images of  $\text{Si}_3\text{N}_4/\text{SiC}$  SCS-6 [0] RBSN samples before and after heat treatment.

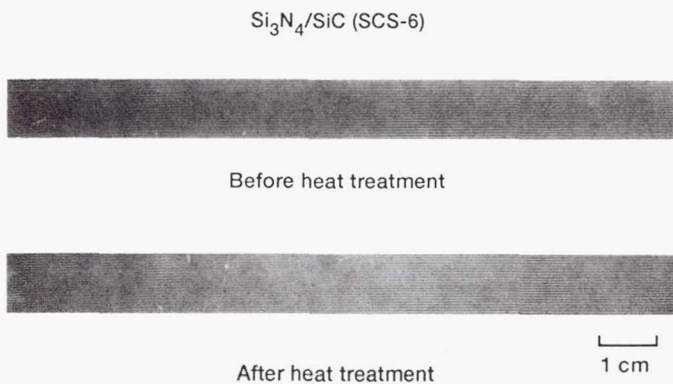
Figure 28.—Radiographs of  $\text{Si}_3\text{N}_4/\text{SiC}$  SCS-6 [0] RBSN sample #2 before and after heat treatment.

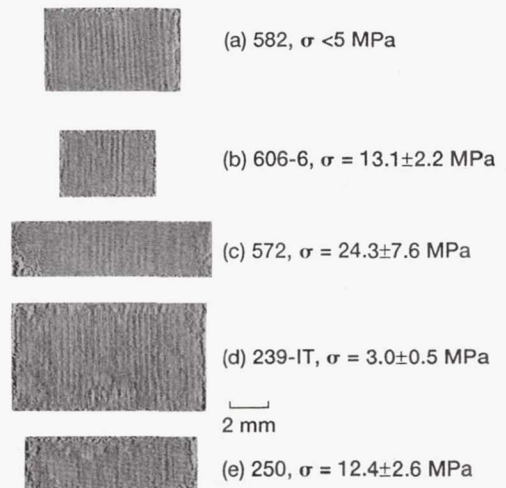
These ultrasonic results are similar (ref. 7) to those found for a series of CMC samples (fig. 29) produced to have a wide range of interfacial bond strengths (fig. 30).

Figure 29.—DERCI images of  $\text{Si}_3\text{N}_4/\text{SiC}$  SCS-6 [0] RBSN samples having a range of interfacial shear strengths.

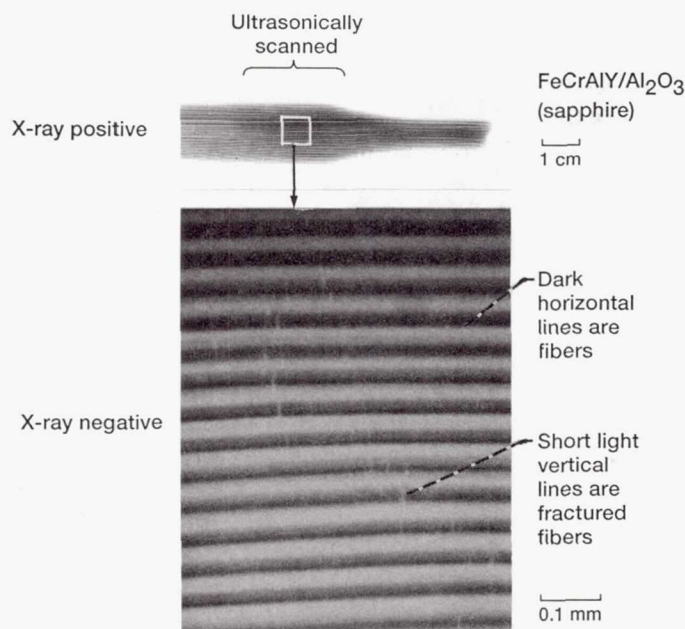
A FeCrAlY/Al<sub>2</sub>O<sub>3</sub> [0] (single crystal sapphire fiber) composite bar was tested in tension at 300 K until failure. Fine cracks in the fibers are barely visible under magnification of the radiograph shown in figure 31. The fibers fractured far away from the test area where the sample ultimately fractured. The horizontal dark and light bands are due to changes in the fiber volume density through the thickness of the sample. This banding, even though it is not cyclic, is produced in an identical way as the Moiré patterns discussed previously. Similar bands have been found in untested samples. A 50 MHz, ultrasonic surface wave examination of the region having cracked fibers also reveals the extent and location of these cracked fibers (fig. 32). A focused 30 MHz, ultrasonic back echo c-scan reveals a mottled matrix material (fig. 32). This mottling is related to the original surface condition (i.e., before the grinding the surface smooth) of the sample. The mottling is most likely due to porosity variations that are dependant on the manufacturing process that creates the "as produced" rough surface. Figure 33 optically shows the "as produced" and "as ground" surface structures. All samples have "as ground" surfaces before being mechanically tested. The radiograph (fig. 31) does exhibit some mottling in the matrix. However, these variations are just barely visible.

Figure 31.—Radiograph and radiographic enlargement of  $\text{FeCrAlY}/\text{Al}_2\text{O}_3$  (sapphire fiber) composite.

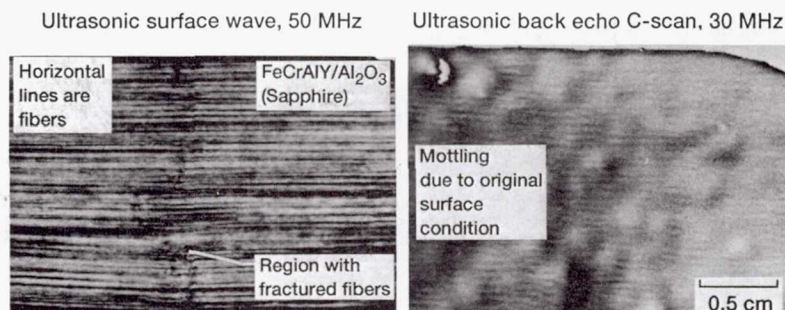
Figure 32.—Ultrasonic surface wave and back echo images of  $\text{FeCrAlY}/\text{Al}_2\text{O}_3$  (sapphire fiber) composite.

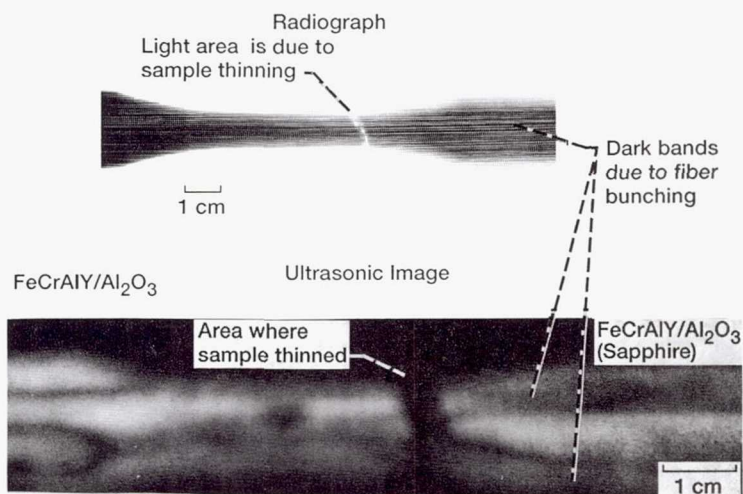
Another FeCrAlY/Al<sub>2</sub>O<sub>3</sub> [0] (single crystal sapphire fiber) sample was tested in tension at 1100 K. The mechanical test was interrupted before the sample fractured. The light region in the x-ray (fig. 34) results correspond to an area that has thinned during the test. The same horizontal light and dark banding due to fiber volume density variations are identified. These fiber volume density variations are also easily observed in the focused 10 MHz, ultrasonic, through transmission c-scan (fig. 34).

Figure 34.—Ultrasonic, 10 MHz, through transmission c-scan and radiograph of FeCrAlY/Al<sub>2</sub>O<sub>3</sub> (sapphire fiber) composite tensile test bar.
